RED ROOF makeover

When copper shows its age, crews use new metal to restore state capitol domes

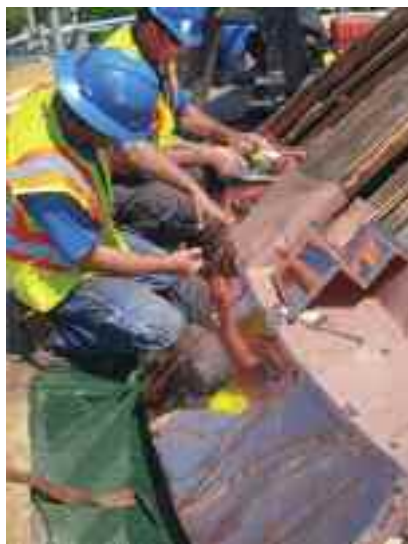
Earlier this year, crews replaced the Maine State House dome's copper with 20-ounce sheet.

Located in Augusta, the Maine State House dome saw the replacement of all 7,000 square feet of copper. According to the Maine State House multiyear maintenance plan in 2013, the dome is over 100 years old and has surpassed its 75-year life expectancy. The State House was built in 1832 and topped out at 185 feet tall after the dome was added during remodeling in 1910. Since 2002, a regular maintenance program has fixed seams, replaced rivets and minor paneling. But continuous weathering steadily wore down the copper's thickness to the point where dime-size holes were appearing in open panel areas. This left the dome vulnerable to leaks and compromised the overall integrity of the copper beyond what maintenance could remedy.

The Heritage Co., a Waterboro, Maine, coppersmithing firm, installed the new cladding, which was supplied by Rome, New York-based producer Revere Copper. The material was 20-ounce sheet in 3-foot by 8-foot sections. All the panels were custom cut and bent to match the prevailing dome's shape either in Her-

itage's shop or on site. The copper was fastened with hidden clips to the underlying substrate, says Grant Pennoyer, executive director of the Legislative Council, the group charged with maintaining the capitol and its grounds.

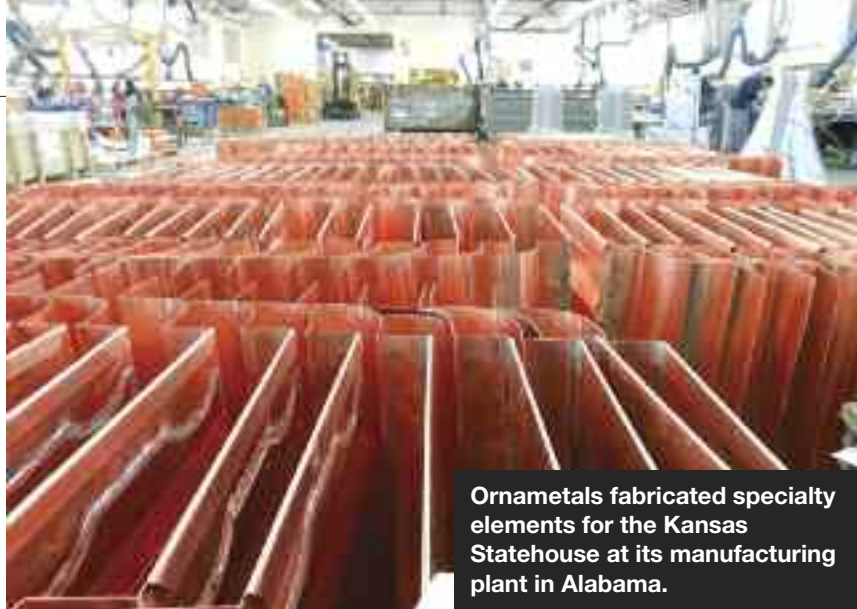
Ornametals fabricated specialty elements for the Kansas Statehouse at its manufacturing plant in Alabama.

According to Carl Holden, marketing manager at Ornametals, the company fabricated copper elements including radius hips, 0.1-millimeter oriel windows, radius bullnoses, 0.8-millimeter rib caps, all radius moldings and stamped radius parts, and the complete cupola lantern including its pommel band and sphere. Aurubis and KME Group, both Europe-based copper makers, supplied Ornametals' material.
